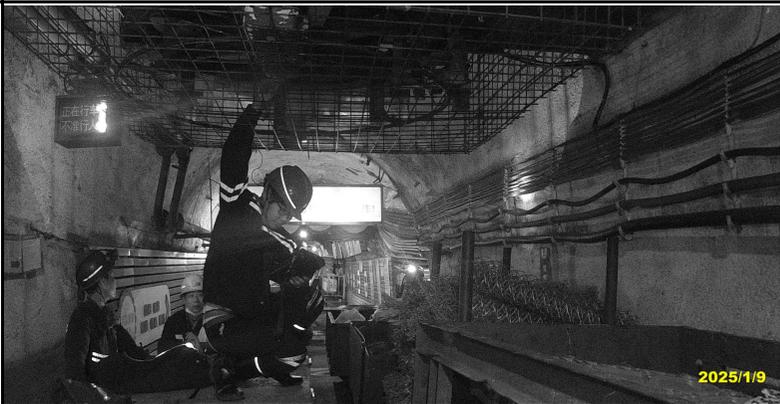
序号	报告编号	发布日期	结论	影像资料
16	GX-B1310/21-5-25009	2025. 2. 10	符合标准要求。

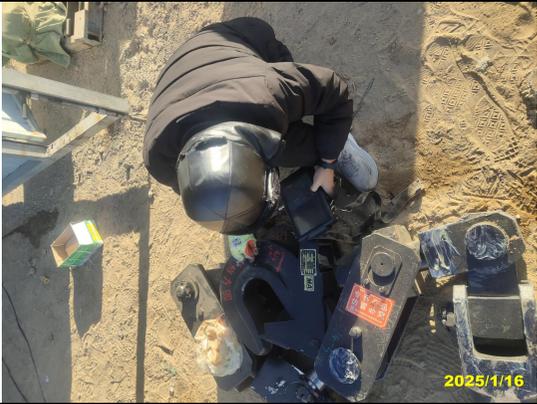
18	GX-B1310/21-5-25011	2025. 2. 11	符合标准要求。

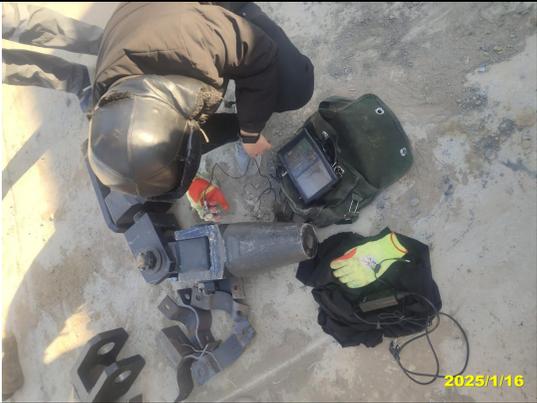
19	GX-B1310/21-5-25012	2025. 2. 11	符合标准要求。

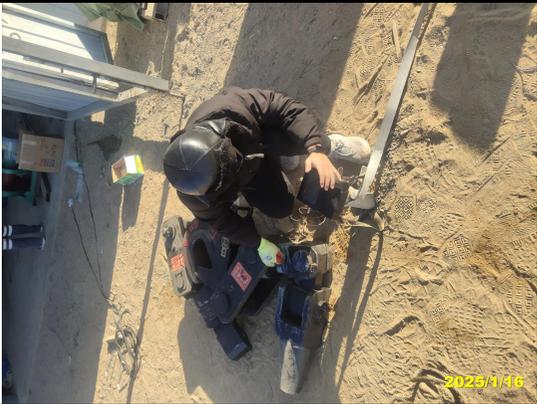
20	GX-B1310/21-5-25013	2025. 2. 11	符合标准要求。

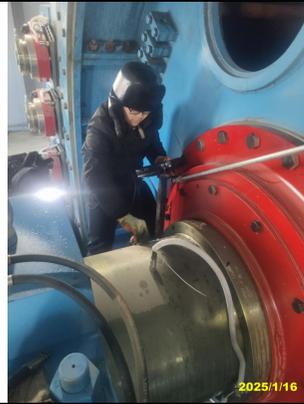
21	GX-B1310/21-5-25014	2025. 2. 11	符合标准要求。

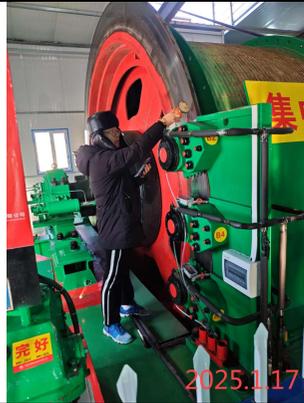
22	GX-B1300/23-5-25002	2025. 2. 11	综合判定：合格。

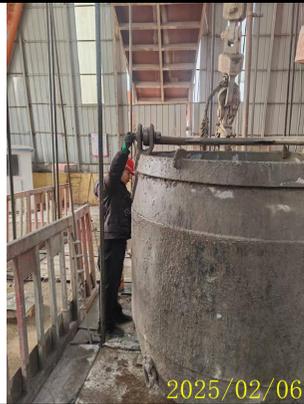
23	GX-B1310/21-5-25015	2025. 2. 11	符合标准要求。

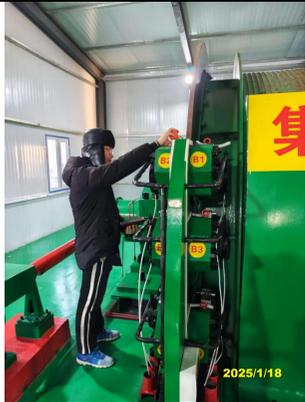
24	GX-B1300/23-5-25001	2025. 2. 11	综合判定：合格。

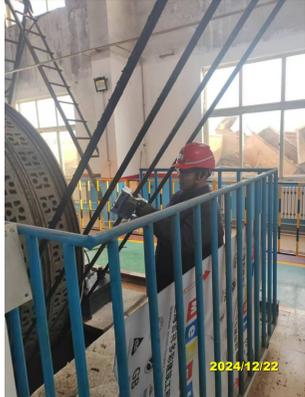
25	GX-B1598/24-5-25001	2025. 2. 12	实测钢丝绳有效截面积损失百分比最大为1.80%，小于5%为正常。
